THE RICS
HOMEBUYER
SURVEY & VALUATION

A larger than average, split level converted maisonette which has been newly converted/refurbished to a high standard overall. A number of general snagging items will need to be attended to by the vendor prior to completion of the sale but in general terms, the property would appear a reasonable proposition for purchase at the price agreed. The location is a little mixed however, siding onto the back of shop/restaurant premises and this may deter some future prospective purchasers, particularly in less buoyant market conditions, when a greater choice of properties may be available.

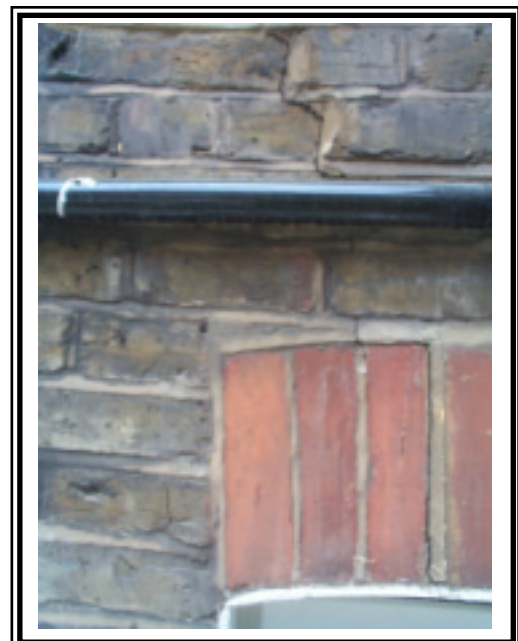
Photo 4 – Cracking over bathroom window

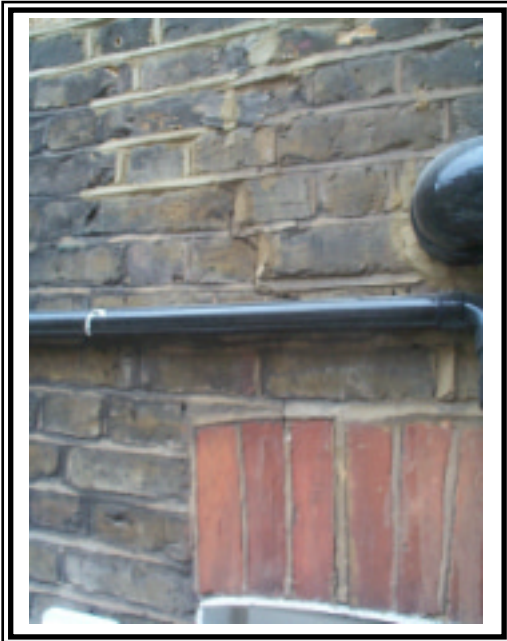
Photo 5 – Cracking/repair over bathroom window

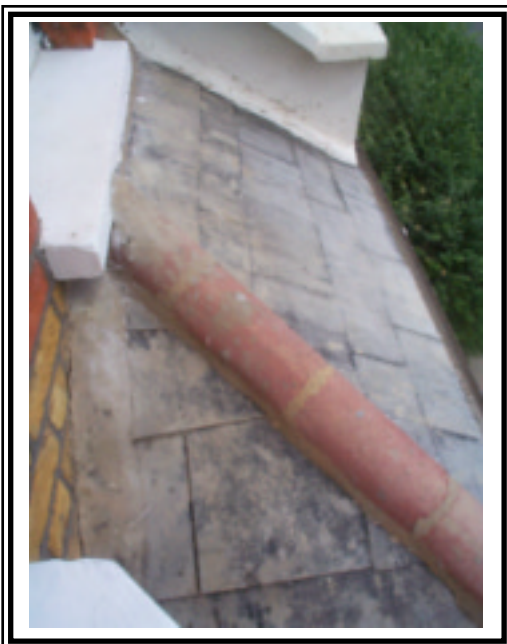
Over the front porch there is a small pitched and hipped roof, re-clad with synthetic slates. The slating is very stained however and unsightly **(see photo 7)** and stripping/recovering would significantly improve the appearance although cleaning at least, should be attempted. The synthetic slating is possibly of some age. Cement fillets are provided at abutments, instead of lead flashings and as is typical, these were found to be cracking. Repairs will be required before long.

Photo 7 – Staining to porch roof

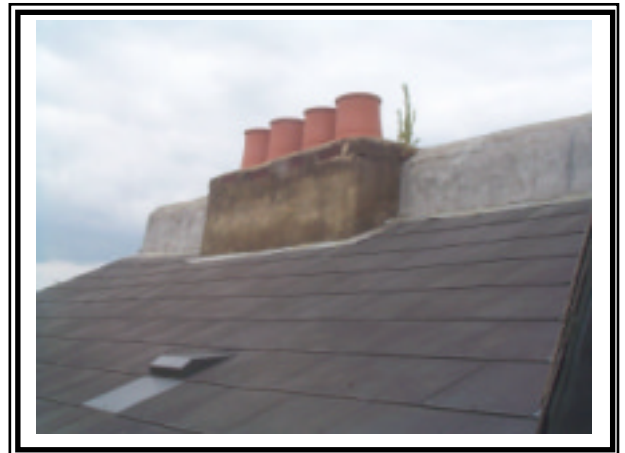
The original back addition chimney stack is shared with the adjoining property to the right and has been reduced in height at some time in the past, and rendered (**see photo 8**). The rendered finish is relatively patchy and its porous condition is indicated by the growth of vegetation from it. The rendering will need to be repaired/renewed as necessary within the next three years or so but in the meantime, redundant flues should be capped off and ventilated to prevent rainwater entry whilst allowing ventilation. Vegetation should also be removed. Rendered finishes to party parapet walls (party walls built up above roof level) will also require further attention in due course and cracks in the rendered finish have been repaired with mastic.

Photo 8 – Back addition roof/chimney stack

- C5 Chimney Stacks: - Capping off/ventilation of redundant flues and rendering repairs to the back addition chimney stack before long.
- C5 Main Walls: - Further repointing of external walls in due course and repair of structural cracking to the back addition flank.
- D2 Drainage: - Precautionary testing of the system prior to purchase, if documentation relating to prior testing/repair is not available.
- C5 Roof Structure and Covering: - Cleaning/replacement (if necessary) of the unsightly/stained slates to the porch roof.
- C5 Rainwater: - Monitoring/redecoration of the fittings.
- D1 Heating: - Commissioning of the combination boiler prior to your occupation.

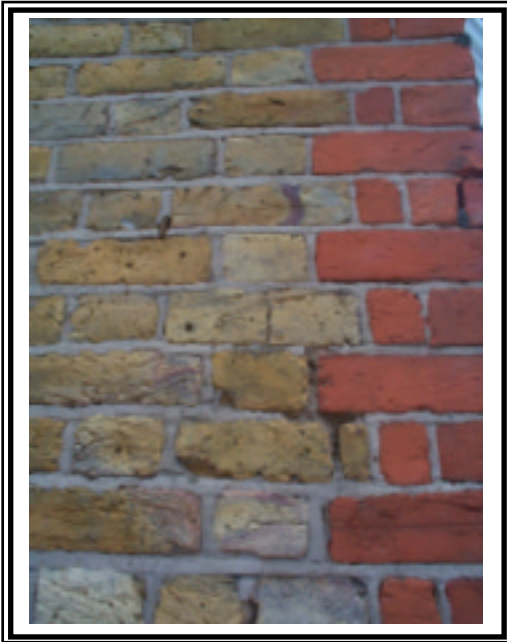
Brickwork to the front elevation and to part of the left hand flank has been cleaned up as part of the refurbishment. The pointing is in patchy condition to these elevations and also to the back addition rear and further repointing will be required in due course (**see photo 9**). Rear/back addition elevations have not been cleaned up and the brickwork is typically discoloured by age and pollution. To the main left hand flank, the lower part of the wall is painted but this finish is in poor condition, necessitating preparation and redecoration. Making good of the brickwork is also required where the boiler flue outlet from the subject flat penetrates the main left hand flank wall, at high level.

Photo 9 – Weathered pointing
