THE RICS
HOMEBUYER
SURVEY & VALUATION

A larger than average, split level converted maisonette which has been newly converted/refurbished to a high standard overall. A number of general snagging items will need to be attended to by the vendor prior to completion of the sale but in general terms, the property would appear a reasonable proposition for purchase at the price agreed. The location is a little mixed however, siding onto the back of shop/restaurant premises and this may deter some future prospective purchasers, particularly in less buoyant market conditions, when a greater choice of properties may be available.

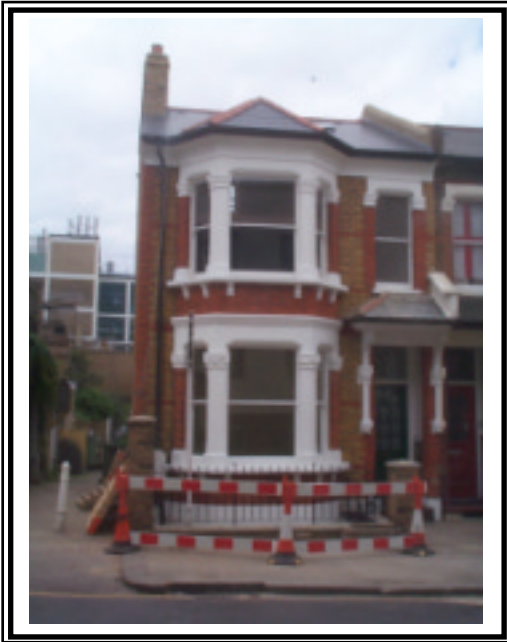
Photo 1 – Front view

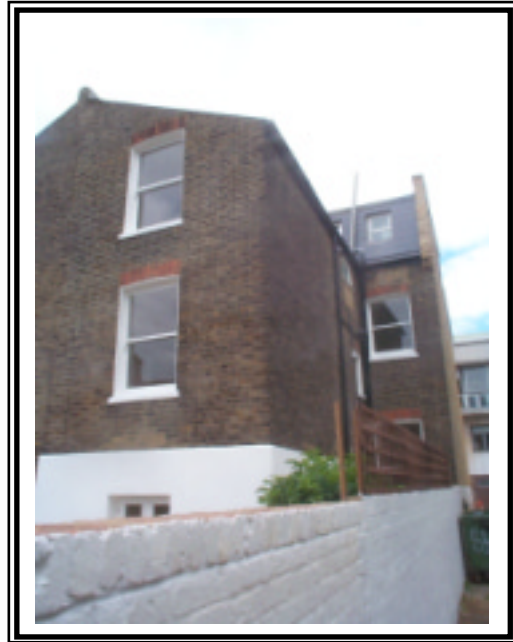
Photo 2 – Rear view

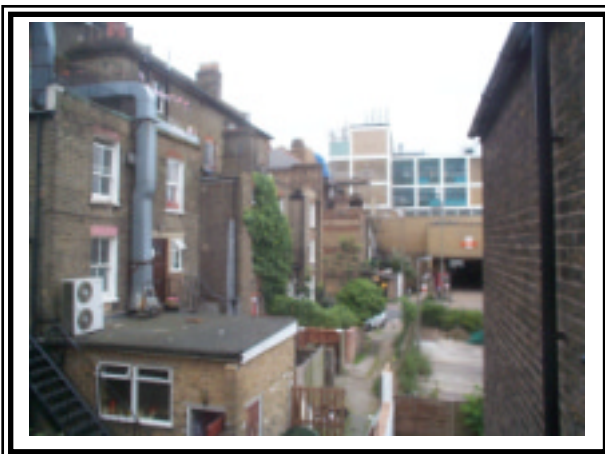
The property is situated within a mixed locality, amongst residential and commercial properties. To the front, the property overlooks the Police Station and Magistrates Court and to the rear, the outlook is across a car park, towards the sorting office (**see photo 3**). The property sides onto the back of a terrace of shops and restaurants, adjacent to a service alleyway. We noted cooking smells at the time of inspection.

Photo 3 – Outlook from rear

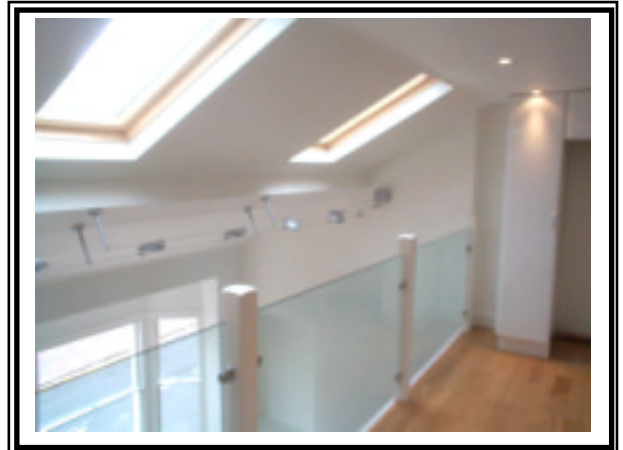
The design of the loft conversion provides a vaulted ceiling to the reception room/kitchen, which slopes in line with the profile of the roof. **(See photo 6)**. The original ceiling joists in the living room would have spanned front to rear and provided a natural tie to the eaves of the roof, to prevent roof spread. The removal of the ceiling joists would have necessitated installation of other measures to prevent the roof moving laterally or "spreading". We have not had sight of the plans and cannot confirm what measures have been put in place in this respect but assuming Building Regulations Approval has been obtained and a Completion Certificate is available, all should be well in this respect. Check of the approved plans may be prudent, however.

Photo 6 – Gallery kitchen
